Mine Name: Reef Mine

Inspection Report Minerals Regulatory Program

April 19, 2010

Permit Number: S/015/0094

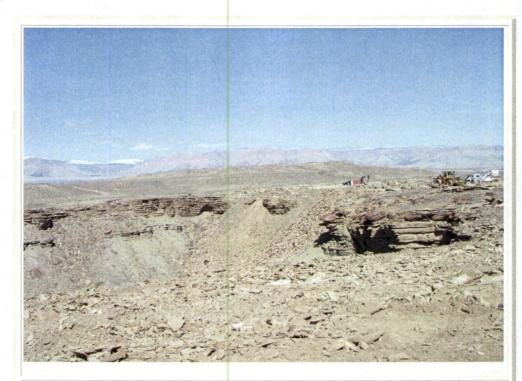
- The Operator did push waste material over the cliff. One concern is that material could be washed down the drainage. The only drainages in the area appear to be ephemeral. Below the cliff, there is a flat area several hundred yards from a well defined ephemeral stream channel. The concern that waste material on the cliff could contribute to increased sediment load appear does not appear to be likely.

- The Operator stated that they placed growth material on the waste material that has been push over the cliff as part of concurrent reclamation.
- The Operator stated that one reason for pushing waste material over the cliff is to stabilize the area. Some of the cliffs are undercut. The waste material acts as a support so that the trackhoe will be stable during the first

Waste material that has been pushed over the side. Some soil material has been placed on the waste material

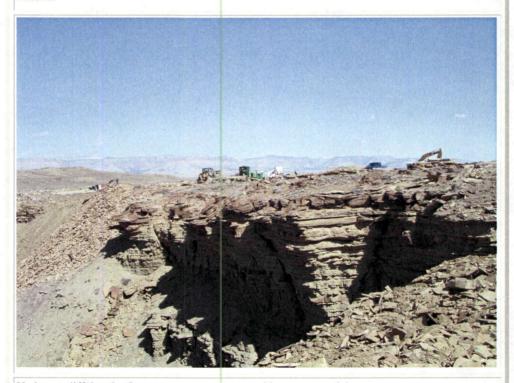
cuts along the cliff face. The Operator likes to start at the cliff edge because the trackhoe has access to exposed layers of rock.

Undercut cliff that the Operator wants to support with waste material

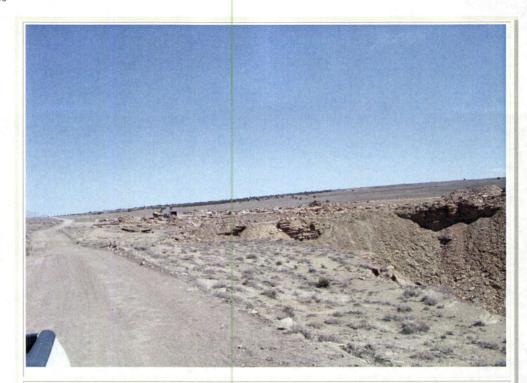
Another view of cliffs

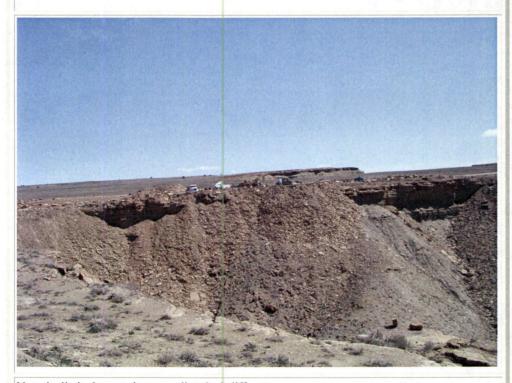
9. The Division recommends that the Operator salvage and store all soils. The mine area has little or no soil; some of the area has exposed bedrock. Because of the limited soil resources, the Division recommends that all soils be salvaged and stored for reclamation.

Note the limited vegetation on undisturbed cliff.
